February 2001

# Little Goose Dan Radial Gate Inspection and Testin

US Army Corps of Engineers, Walla Walla District

# LITTLE GOOSE DAM RADIAL GATE INSPECTION AND TESTING

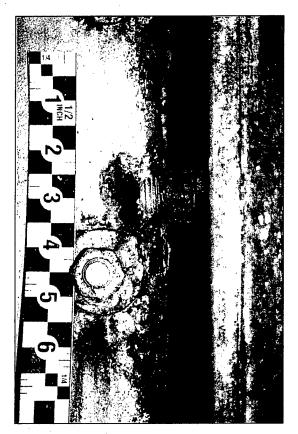
Photo. 18: Side seal from downstream side, light to moderate corrosion on skin plate, seal angles, nuts and bolts, typical condition.

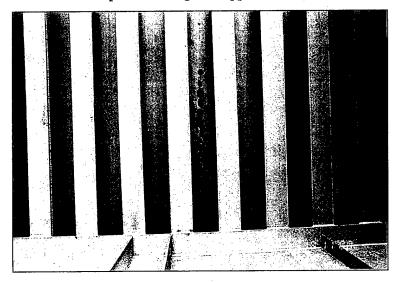
There is a line of light to moderate corrosion on the downstream side of the skin plate just above the top horizontal girder approximately 10 feet from the left side of the gate.

Photo. 25: Moderate corrosion on downstream surface of skin plate.

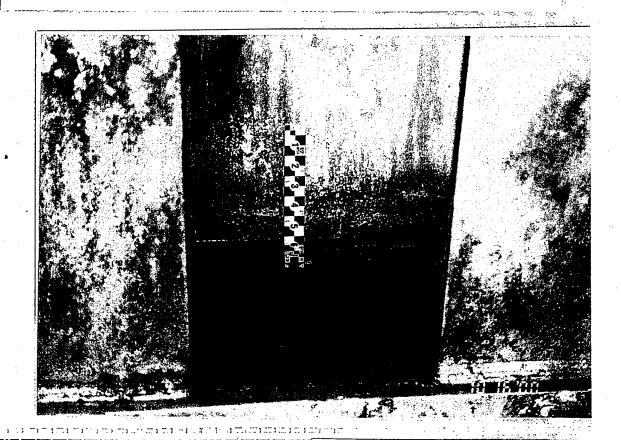
Little Goose Dam 10/16/00 Gate 1
Bottom seal closure plate looking upstream. Standing water between closure plate, purlin webs and skinplate. Typical.

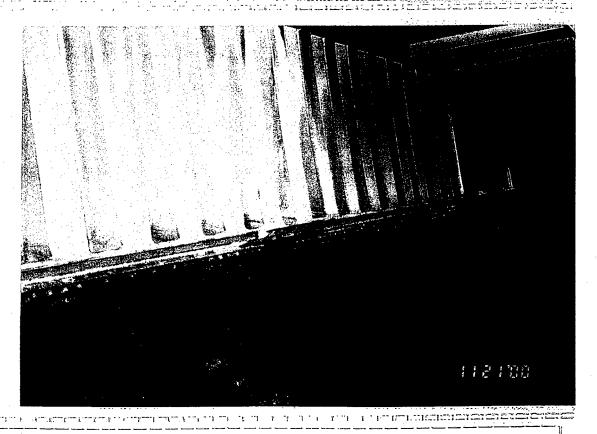
Bottom of left side of gate at 3' open. Note: Heavy falling water due to stop log leakage precludes inspection of hoist connections.

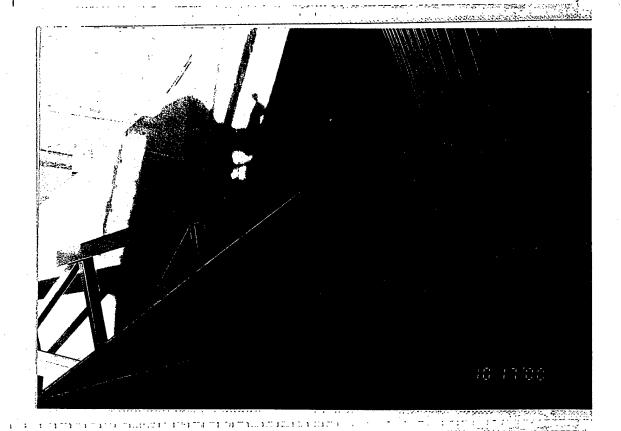
Little Goose Dam Gate 2
Top of top horizontal girder looking towards right frame, typical.

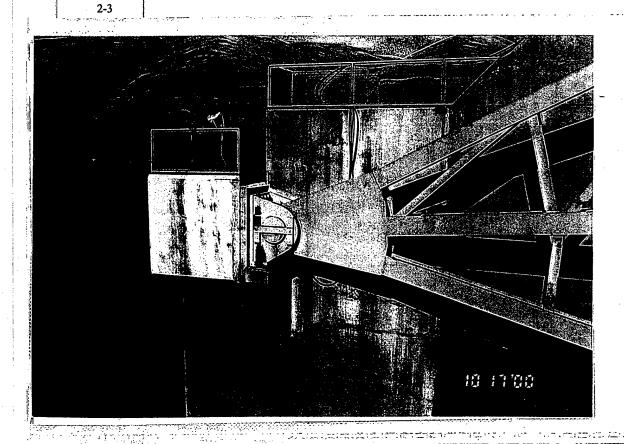
Little Goose Dam Gate 2
Right trunnion and trunnion block, typical.

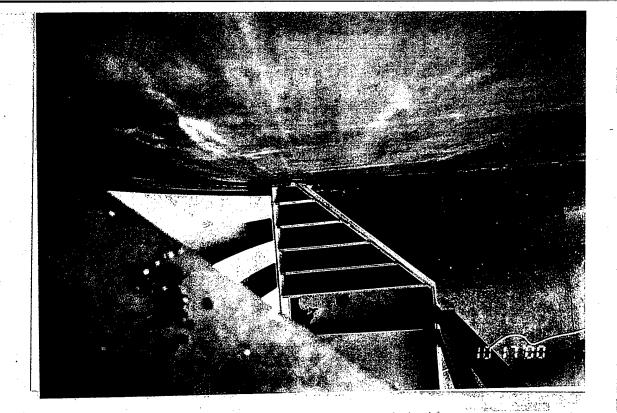
2-5

Gate 2
Bottom horizontal girder, left end.
Standing water, no drainage between multiple stiffeners, typical.

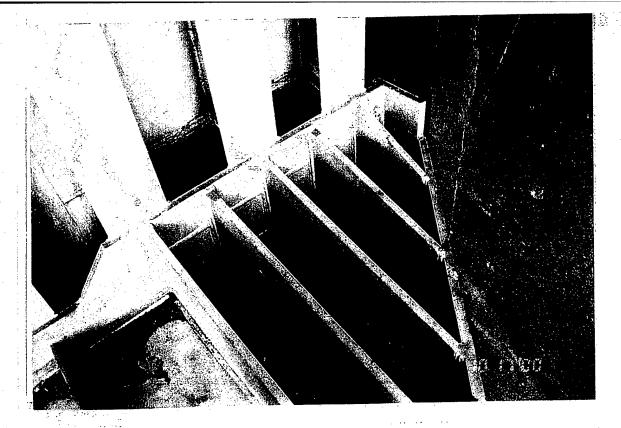
2-11

Gate 2
Bottom horizontal girder, left end.
Standing water, no drainage between
multiple stiffeners, typical.

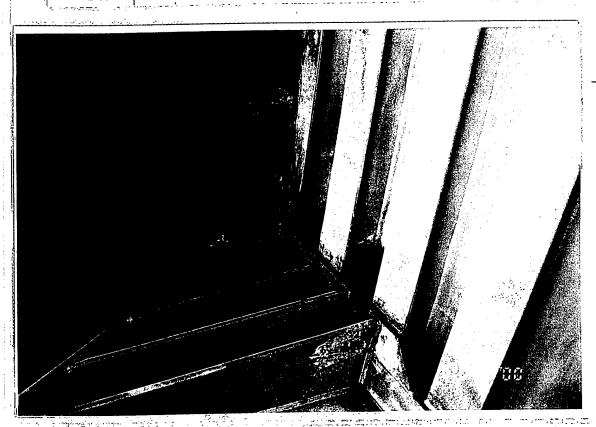
Little Goose Dam Gate 2
Bottom horizontal girder, Right end.
Standing water, no drainage between
multiple stiffeners, typical.

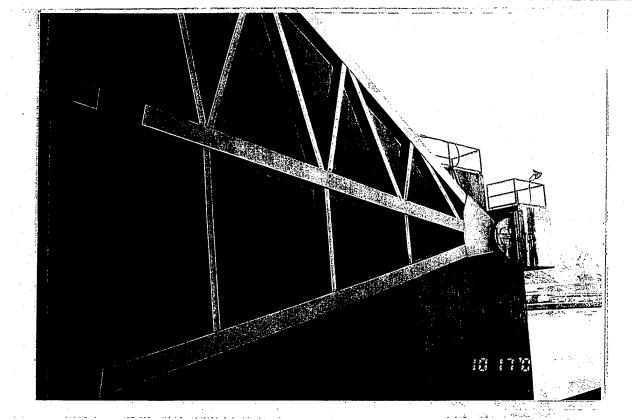
2-13

Gate 2 Left frame, typical.

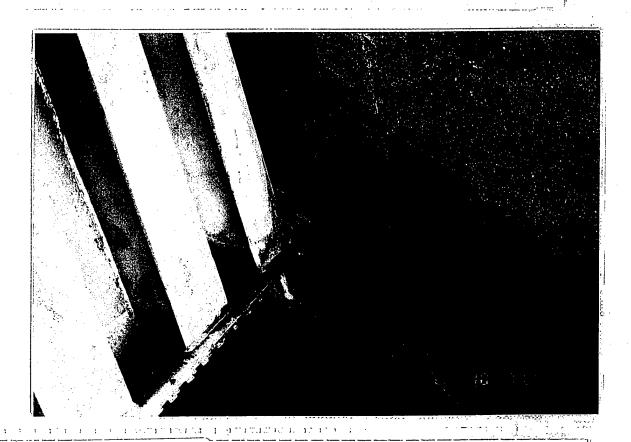
Gate 2
Leak, bottom left corner of gate.
Bottom seal closure plate. Standing water between closure plate, purlin webs and skinplate. Typical.

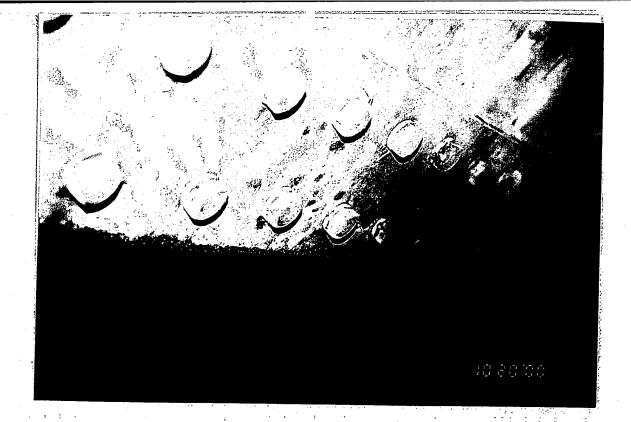
Gate 2 Bottom seal keeper plate, typical.

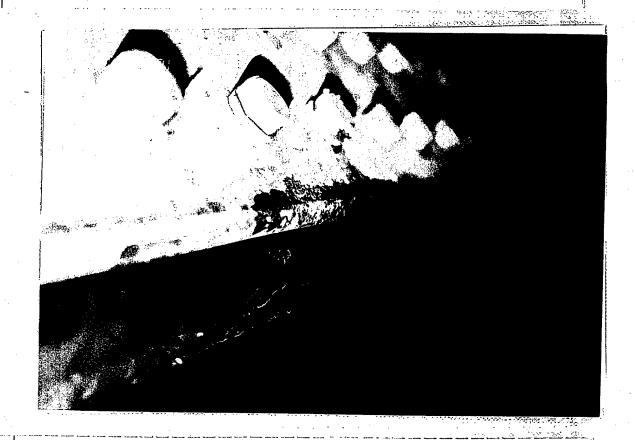
Little Goose Dam Gate 2
Bottom seal, typical.

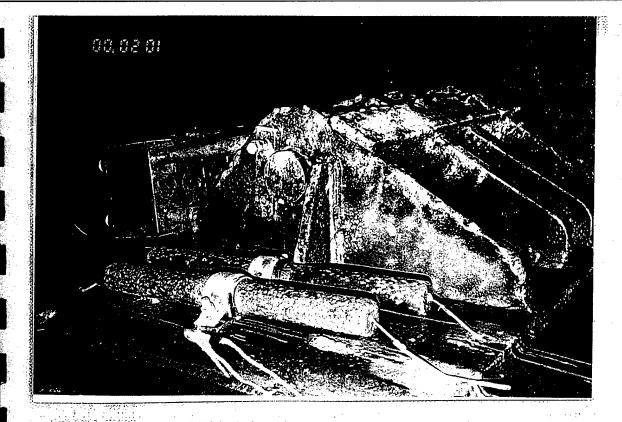
Gate 2 Right hoist connection and zinc anodes. Light corrosion on lifting lugs.

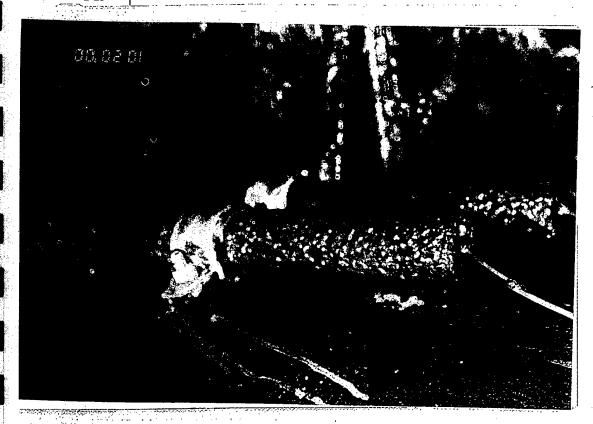
Little Goose Dam Gate 2
Zinc anodes, good condition.

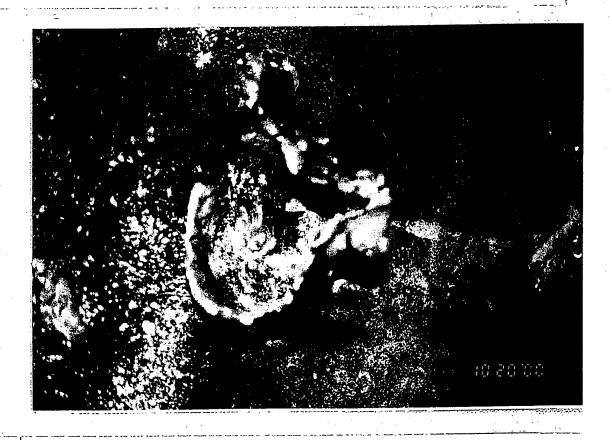
2-25

Gate 2
Bottom of hoist connection. Light corrosion on plates.

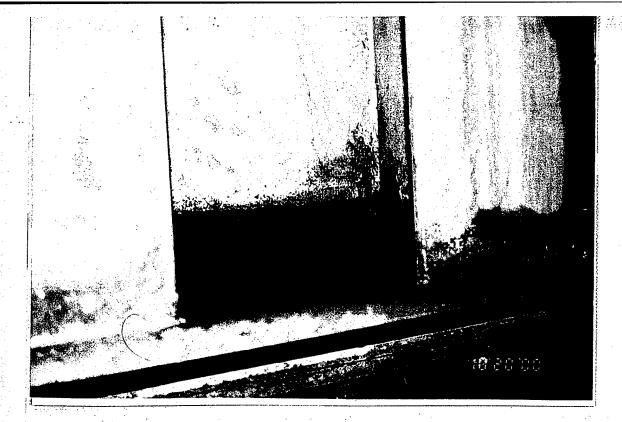
Gate 2
Bottom seal closure plate looking upstream. Standing water between closure plate, purlin webs and skinplate. Typical.

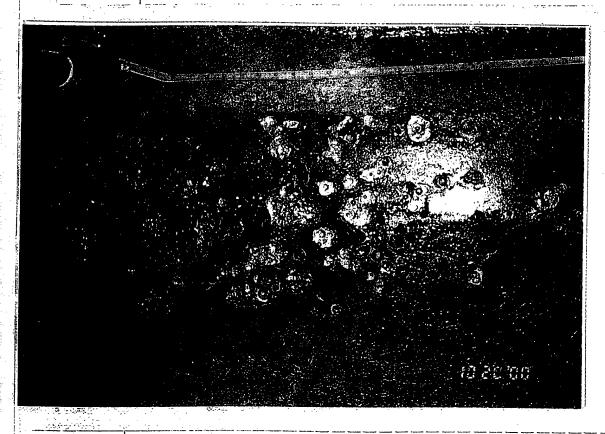
Little Goose Dam Gate 2 Skin plate pitting, typical.

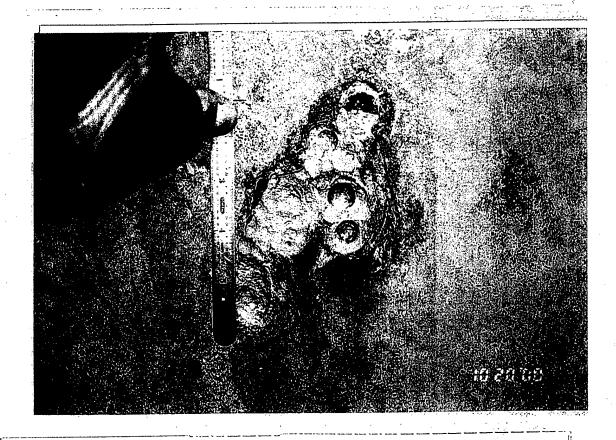
Gate 2
Skin plate pitting, typical.

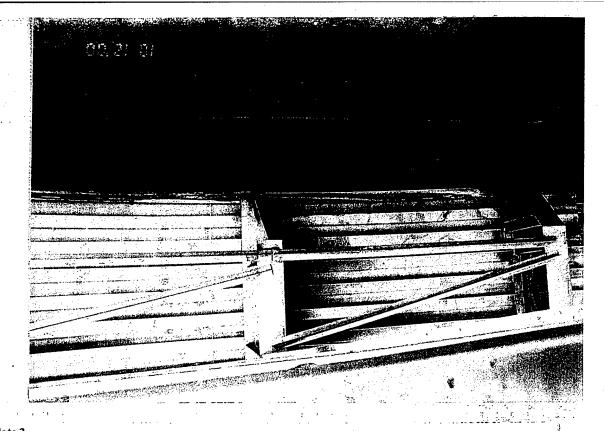
Gate 3 Left side of gate. Light corrosion on members.

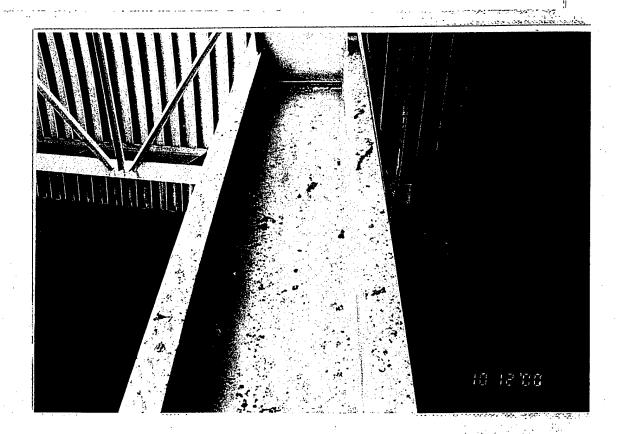
Gate 3 Left frame, middle radial strut, typical.

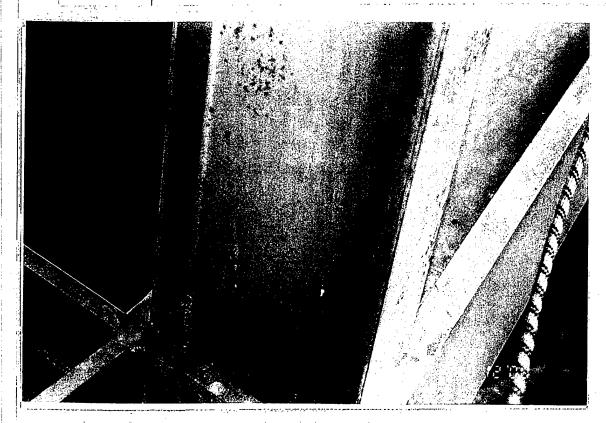
Little Goose Dam Gate 3
Left frame, Brace A. Light corrosion on upstream side.

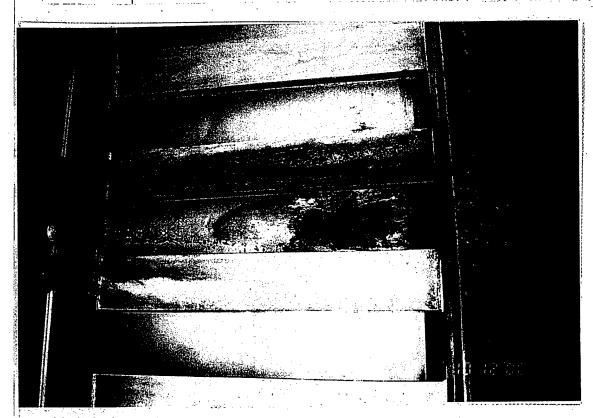
Little Goose Dam 10/12/00 Gate 3
Standing water between closure plate, purlin webs and skinplate, typical.
Light corrosion around drain hole at upstream side of bottom radial strut.

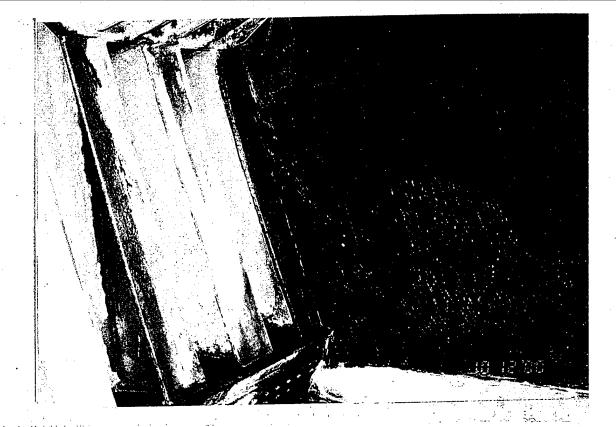
Gate 3
Side seal leak, bottom left corner of gate. Standing water between closure plate, purlin webs and skinplate, typical.

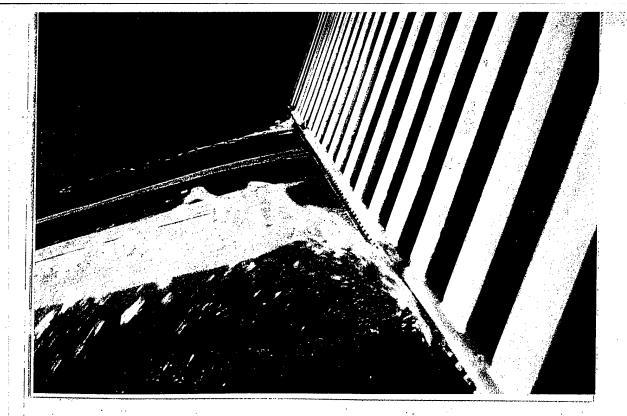
Gate 3
Leak at center construction joint in spillway monolith.

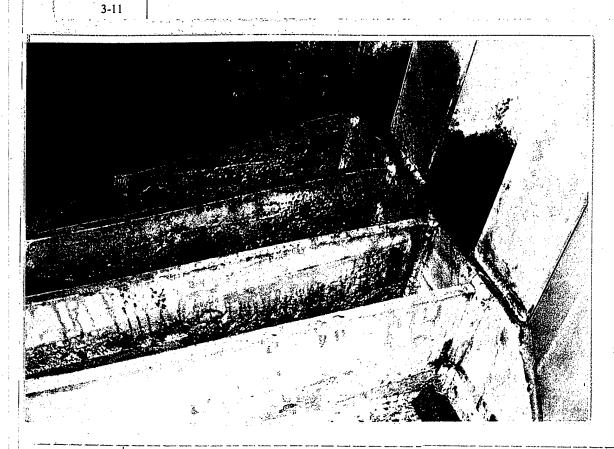
Little Goose Dam 10/12/00 Gate 3
Bottom horizontal girder, right end.
Standing water, no drainage between multiple stiffeners, typical.

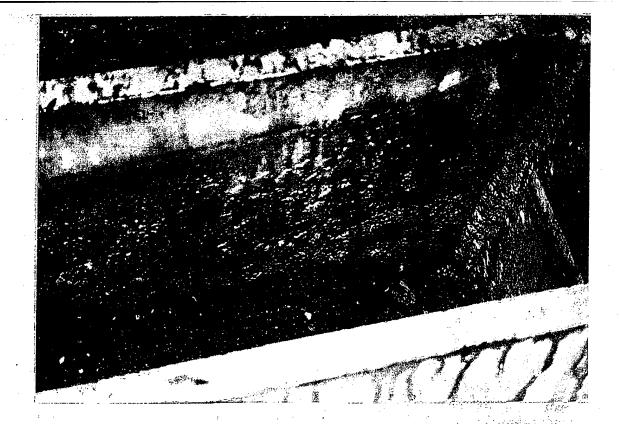
Gate 3 Close-up, bottom horizontal girder. Standing water, no drainage between multiple stiffeners, typical.

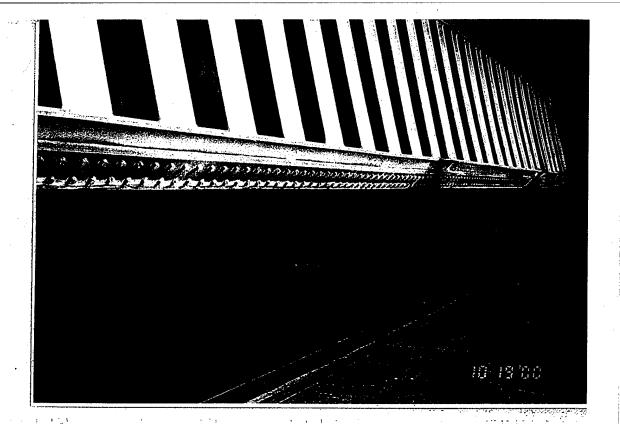
Bottom of left side of gate at 3' open. Note: Heavy falling water due to stop log leakage precludes inspection of hoist connections.

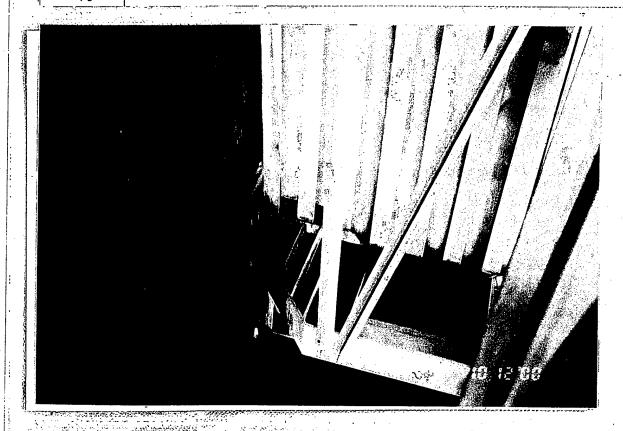
Bottom horizontal girder, left side. Standing water, no drainage between multiple stiffeners, typical. Side seal leak.

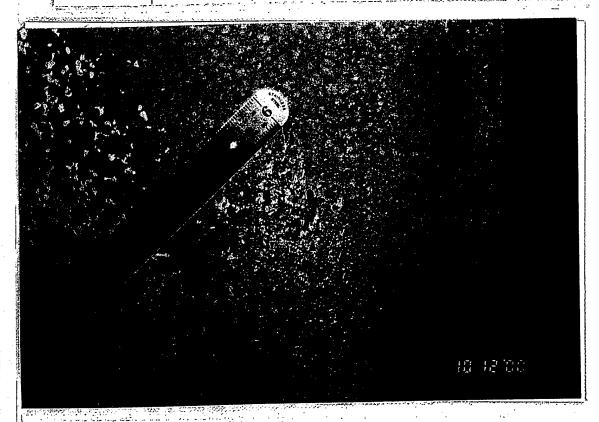
Gate 4
Brace J, left frame. Small scratches
on web.

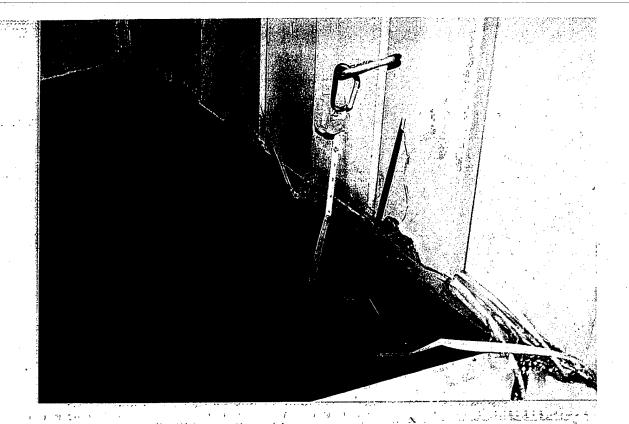
Gate 4
Downstream side of skin plate, right side of gate above bottom horizontal girder. Possible previous skin plate repair.

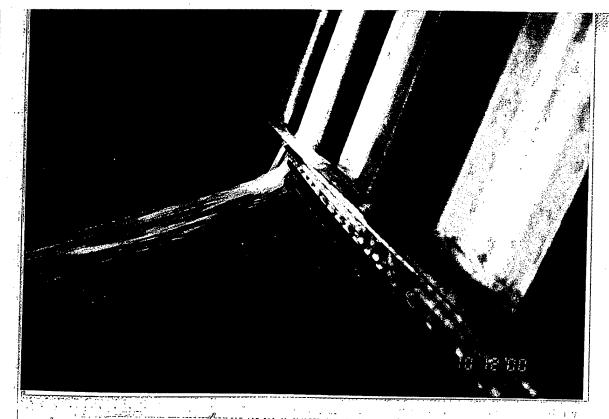
Gate 4
Standing water between closure plate, purlin webs and skinplate, typical.
Bottom right corner seal leak. 10/12/00

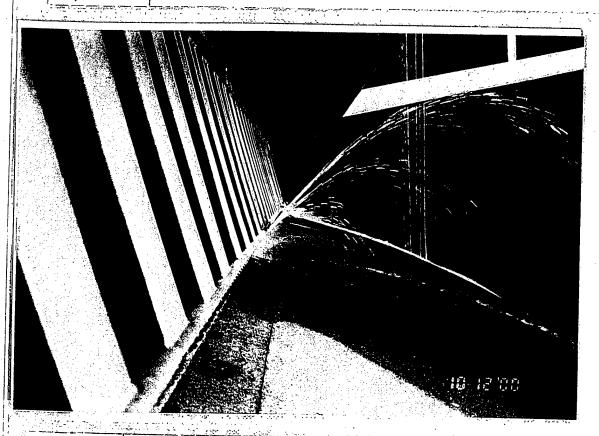
Gate 4
Leak at center construction joint in spillway monolith.

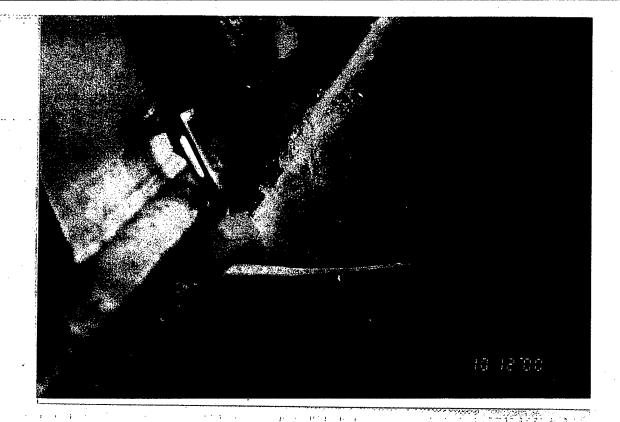
Gate 4 Leak at center construction joint in spillway monolith.

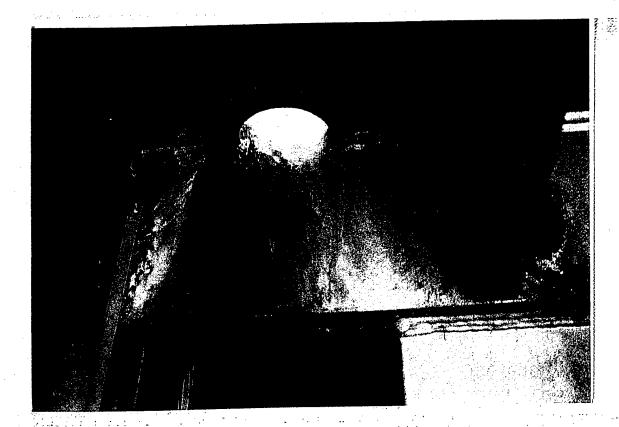
Little Goose Dam 10/12/00 Gate 4
Bottom of bottom horizontal girder, upstream flange and stiffener.
Moderate corrosion due to horizontal girder drain hole above.

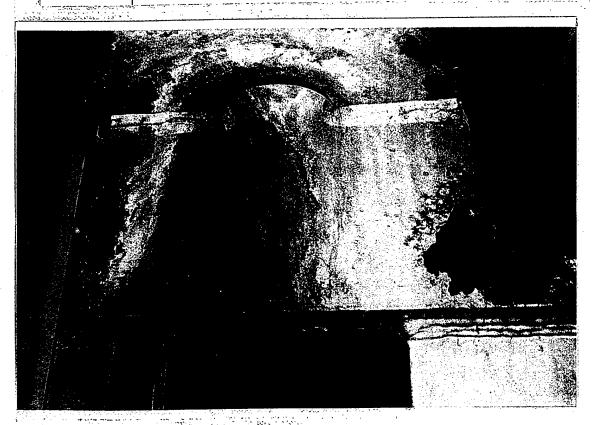
Gate 4
Bottom of bottom horizontal girder.
Drain hole for upstream side of bottom horizontal girder. Light to moderate corrosion on surrounding members.

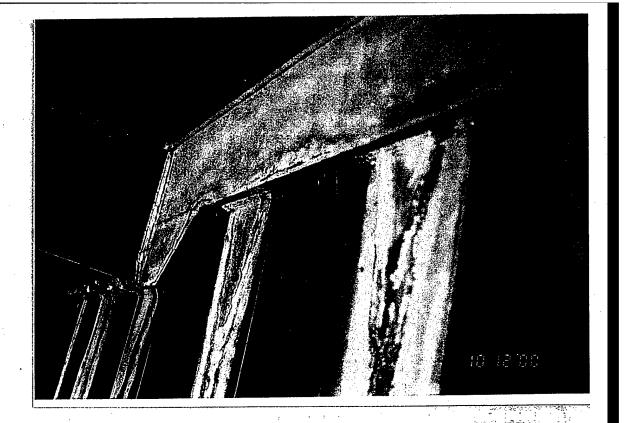
Gate 4
Bottom of bottom horizontal girder.
Drain hole for upstream side of
bottom horizontal girder. Light to
moderate corrosion on surrounding
members.

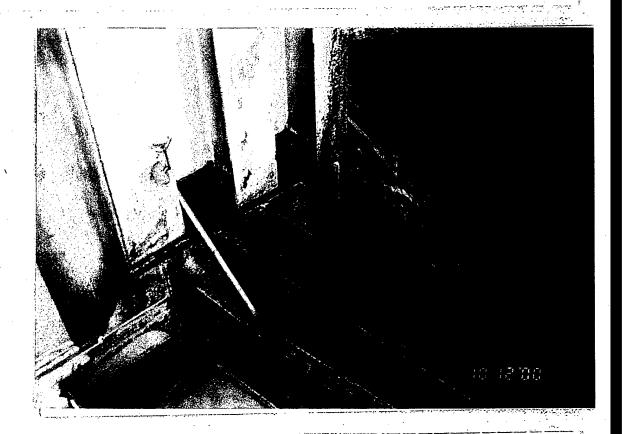
4-17

Gate 4
Bottom of bottom horizontal girder, light corrosion on girder, stiffeners and purlins.

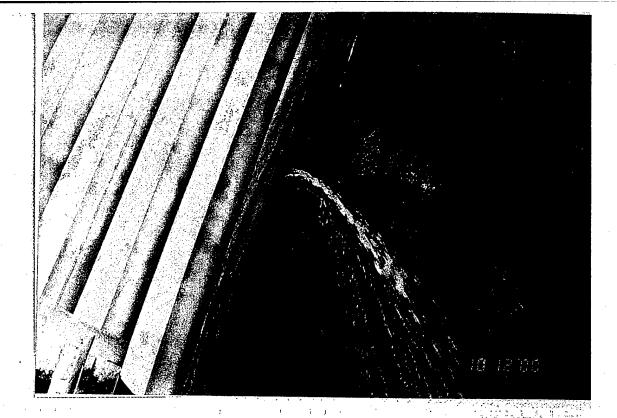
4-21

Gate 4
Side seal leak, left side of gate.

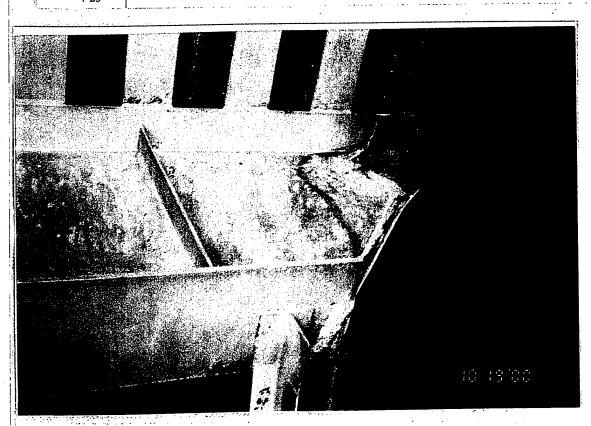
Little Goose Dam 10/19/00 Gate 4
Top horizontal girder, left side. 2" to 3" deformation upward in girder web.

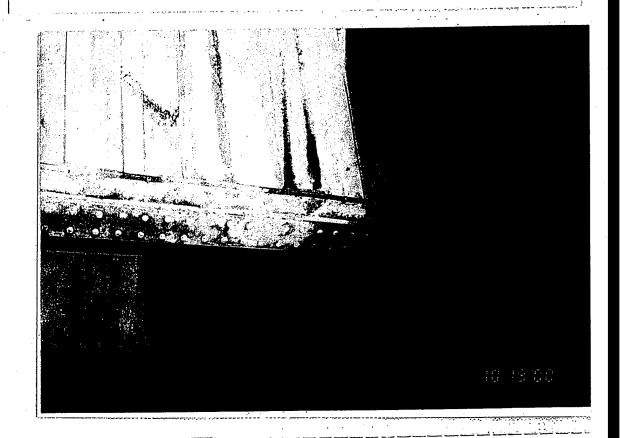
Little Goose Dam Gate 4
Bottom left corner of gate, typical.

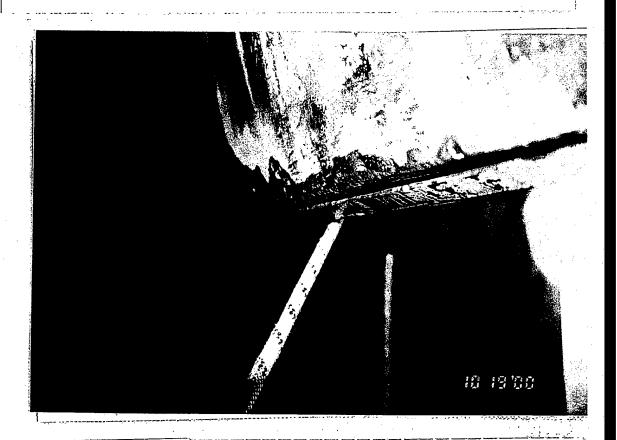
Little Goose Dam Gate 4
Bottom seal and bottom upstream side of skin plate. Moderate corrosion at bottom edge of skin plate.

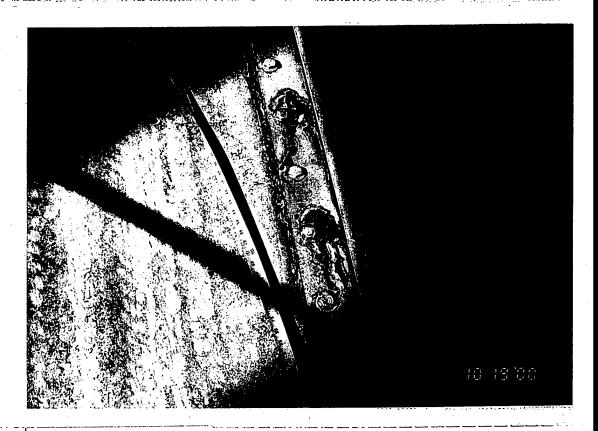
Little Goose Dam Gate 4
Side seal angles, wear plate and side seal, typical.

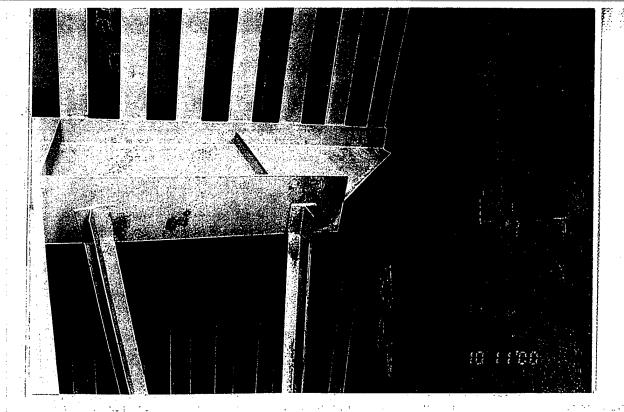
Gate 5
Downstream side of skin plate, left side of gate, above top horiz. girder. Peeling pain, light corrosion.
Appears to be possible paint blister due to upstream skin plate welding.

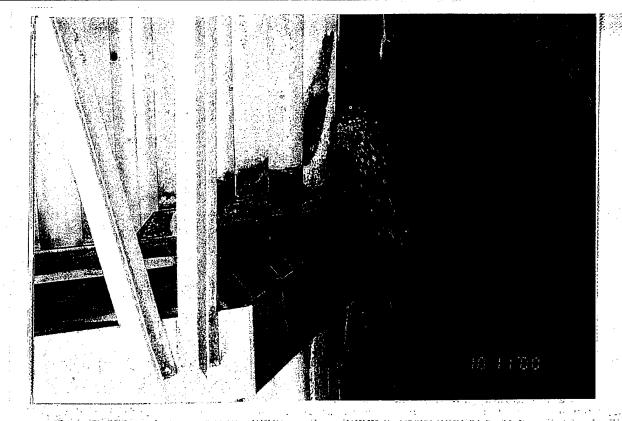
5-7

Gate 5
Bottom horizontal girder, left end.
Standing water, no drainage between multiple stiffeners, typical.

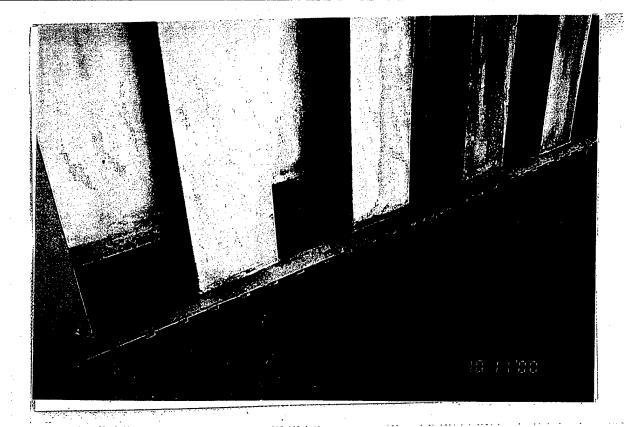
Gate 5
Bottom left corner of gate, bottom seal leak. Bottom seal closure plate. Standing water between closure plate, purlin webs and skinplate, typical.

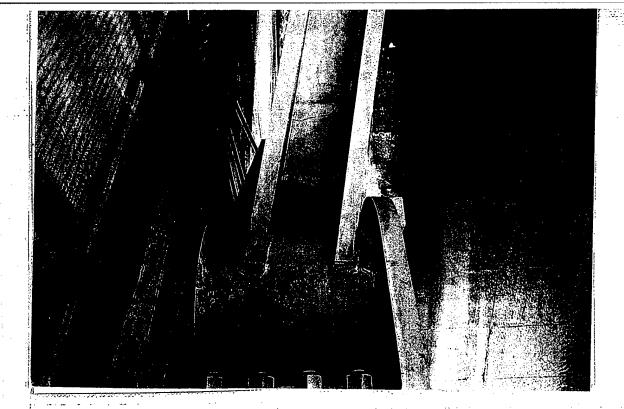
Gate 5
Top of right trunnion. Standing water due to inadequate drainage in top radial strut web.

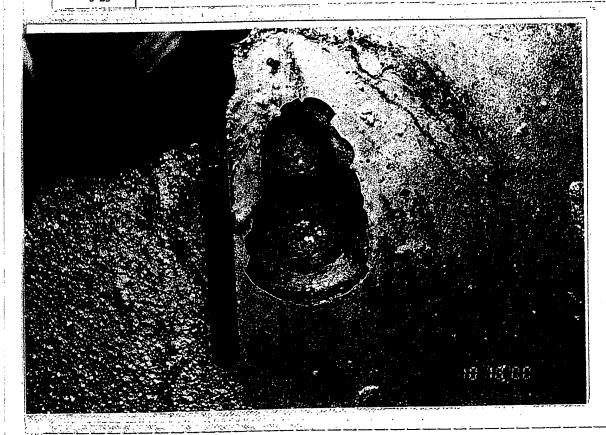
Photo. 6: Wear plate pitting - heavy, typical. Hemispherical shape is indication of microbially influenced corrosion.

Gate 5
Heavy pitting on wear plate, typical.

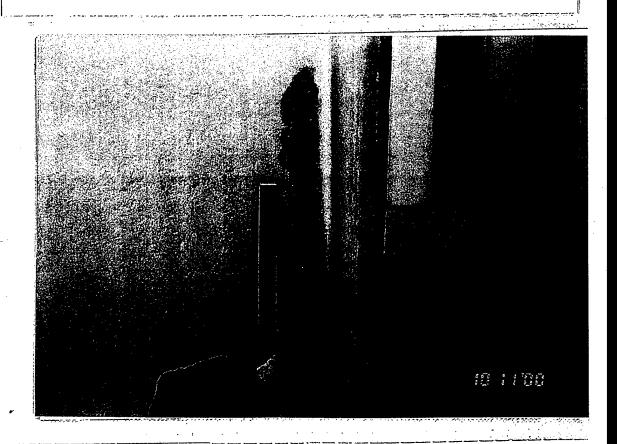
6-1

Little Goose Dam Gate 6
Left frame, Brace B. Light corrosion on brace.

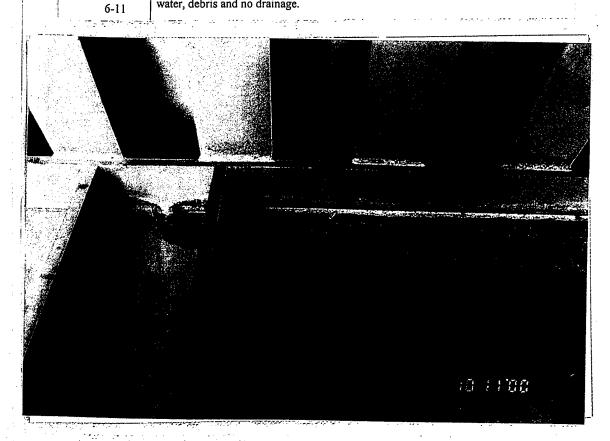
6-12

Little Goose Dam Gate 6
Bottom horizontal girder. Evidence of standing water on girder web and flange.

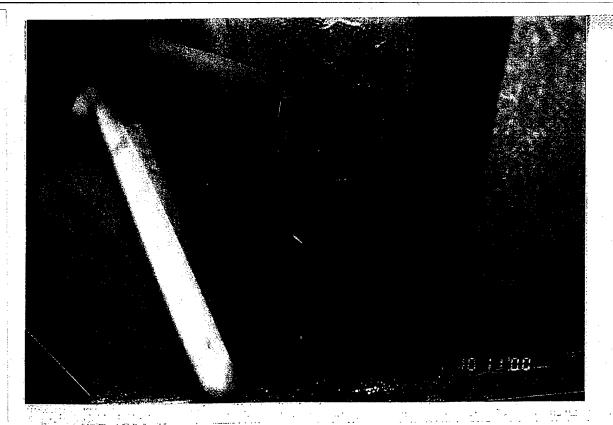
6-15

Bottom seal closure plate, standing water between closure plate, purlin webs and skinplate, typical.

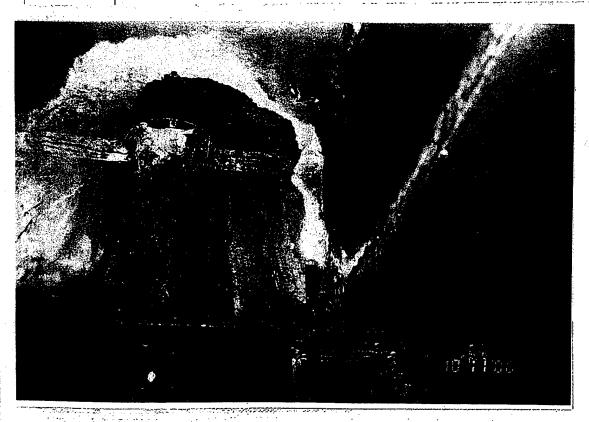
6-16

Little Goose Dam Gate 6
Bottom of bottom horizontal girder at radial strut connection and girder drain hole. Light corrosion on girder web and stiffeners.

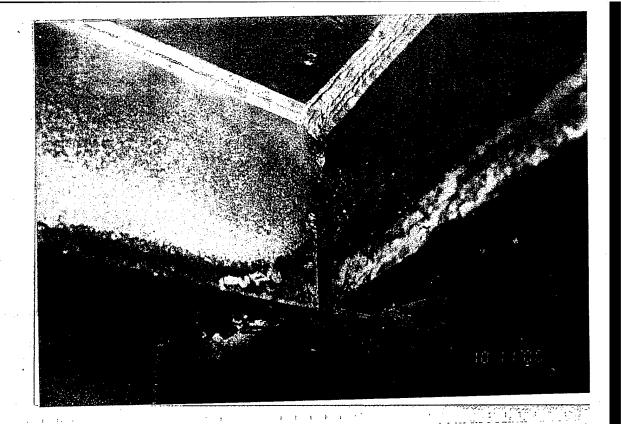
6-17

Gate 6
Bottom of bottom horizontal girder at radial strut connection and girder drain hole. Light corrosion on girder web and stiffeners.

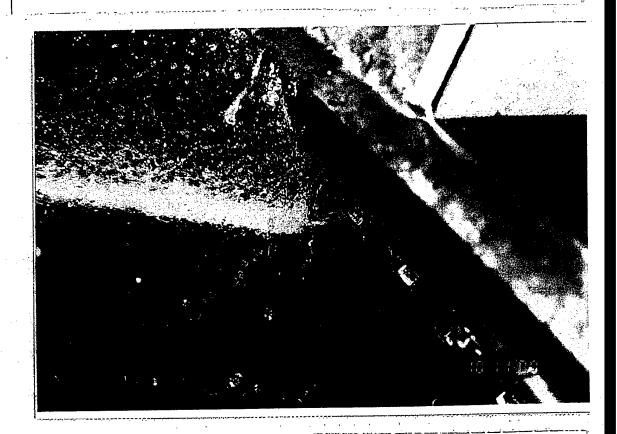
Little Goose Dam Gate 6
Leak at center construction joint in spillway monolith. Light corrosion on bottom seal keeper plate.

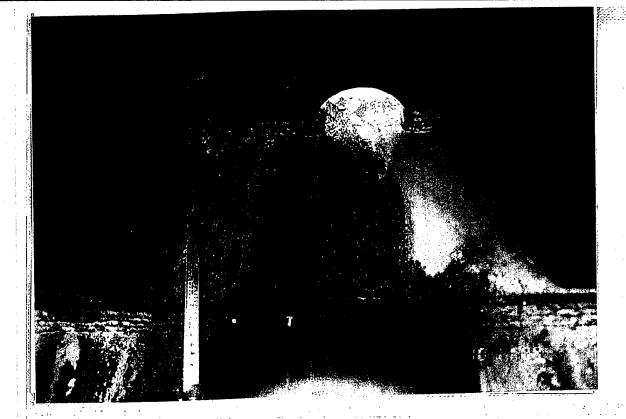
6-19

Gate 6
Bottom of bottom horizontal girder at radial strut connection and girder drain hole. Light corrosion on girder web and stiffeners.

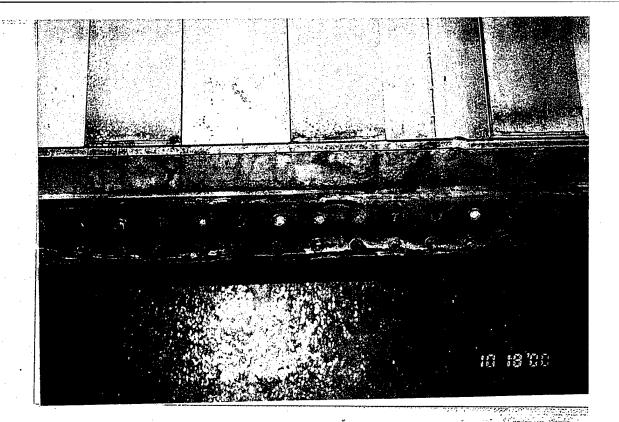
6-25

Gate 6 Bottom seal keeper plate, typical.

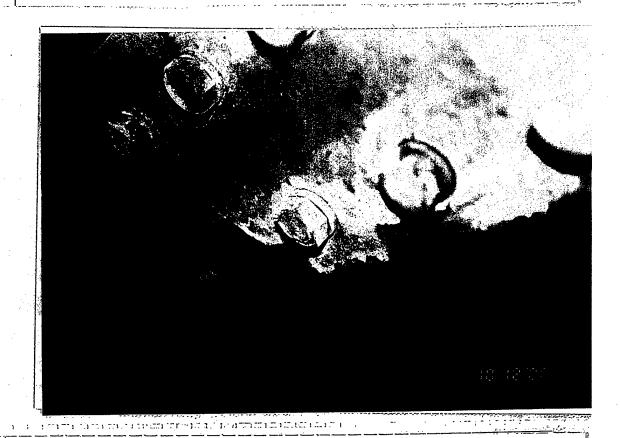
Gate 6
Bottom seal keeper plate, typical.

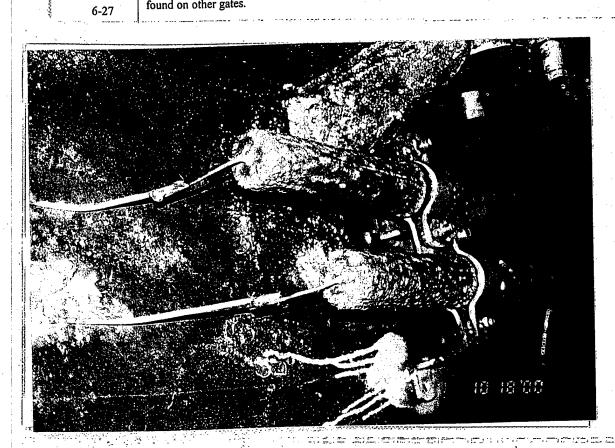
Left hoist connection and anodes.
Light to moderate corrosion on
lifting lugs and plates. Note: Extra
anode under hoist connection not
found on other gates.

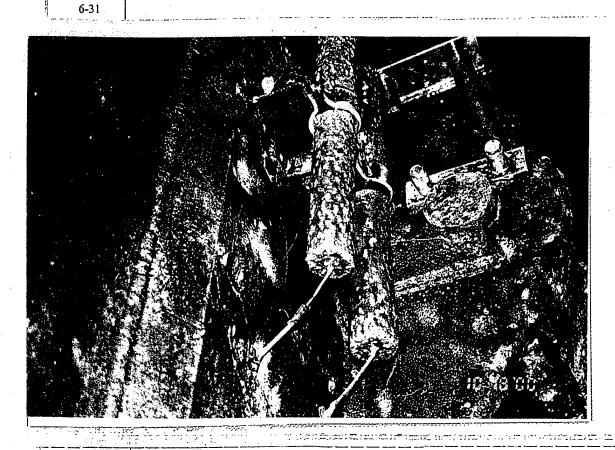
Little Goose Dam Gate 6
Right hoist connection. Light to moderate corrosion on lifting lugs and plates. Note: Generally good condition of anodes.

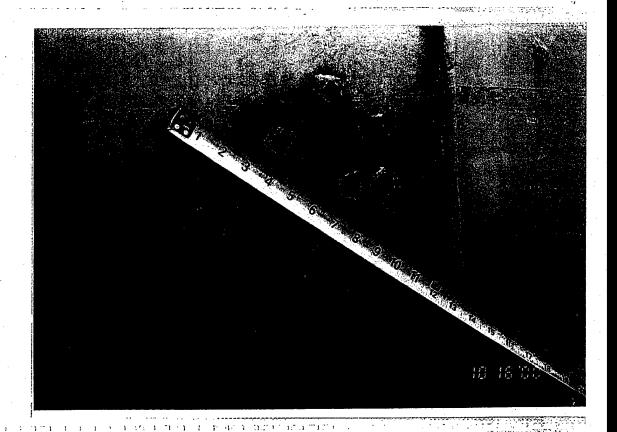
Gate 6
.Skin plate pitting, typical.

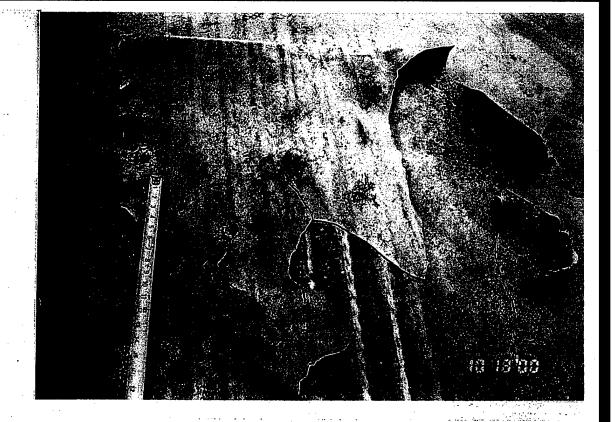
Gate 6
Left wear plate. Delaminated vinyl coating.

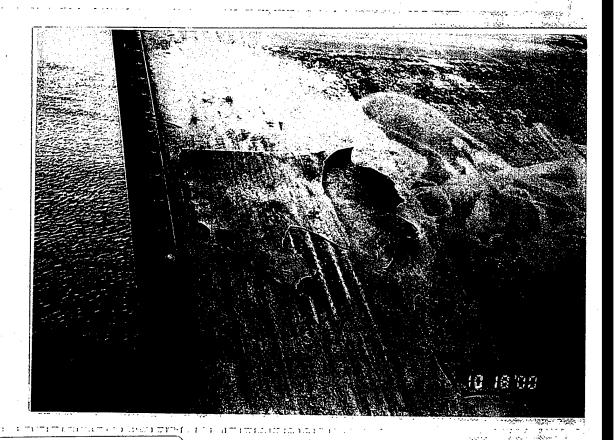
6-37

Gate 6
Left wear plate. Delaminated vinyl coating.

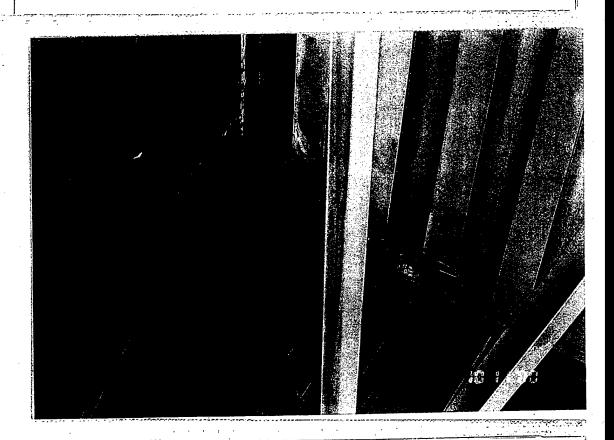
Little Goose Dam Gate 7
Bottom horizontal girder, right end.
Standing water, no drainage between multiple stiffeners, typical.

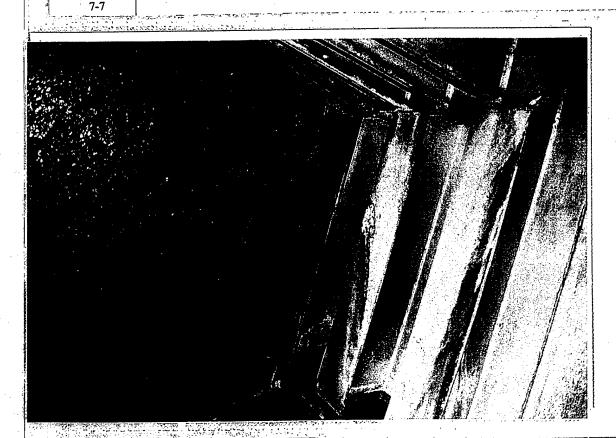
Little Goose Dam Gate 7
Bottom right corner of gate, side seal leak.

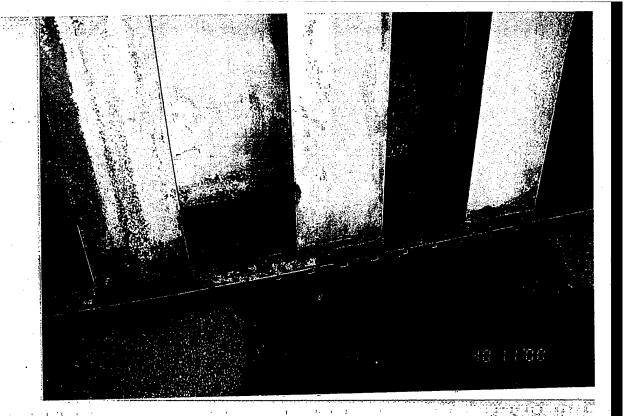
7-9

Gate 7
Bottom seal closure plate looking upstream. Standing water between closure plate, purlin webs and skinplate. Typical.

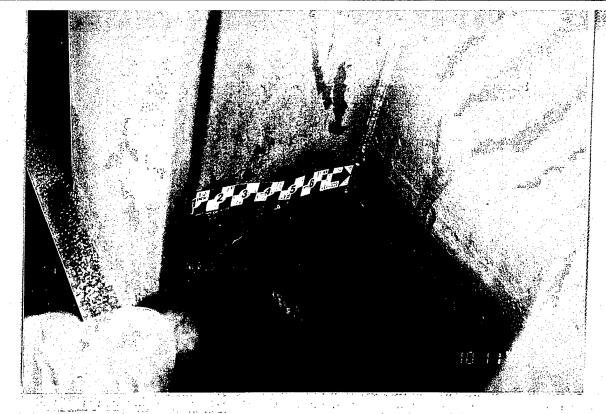
7-11

Gate 7
Bottom seal closure plate looking upstream. Standing water between closure plate, purlin webs and skinplate, typical.

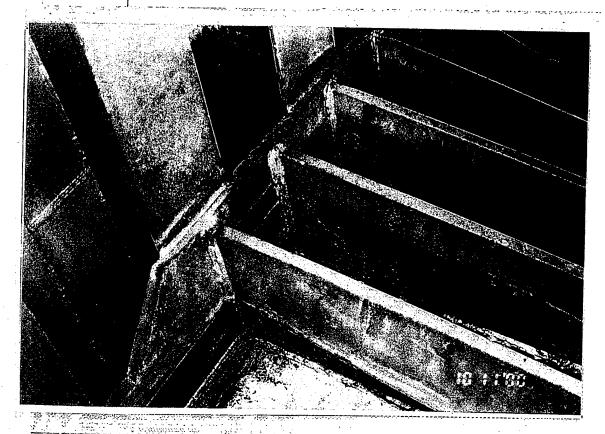
Little Goose Dam Gate 7
Bottom horizontal girder, left end.
Standing water, no drainage between multiple stiffeners, typical.

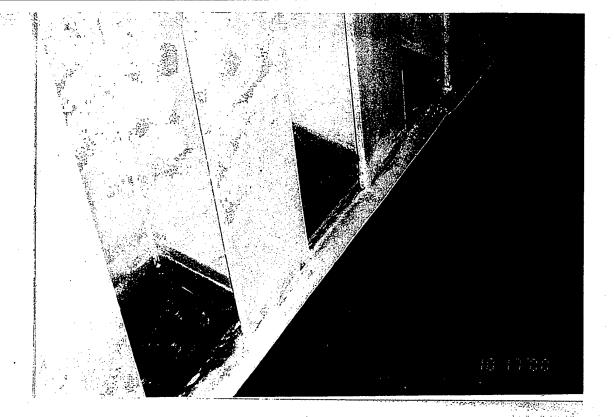
7-13

Gate 7 Bottom seal closure plate. Standing water between closure plate, purlin webs and skinplate, typical.

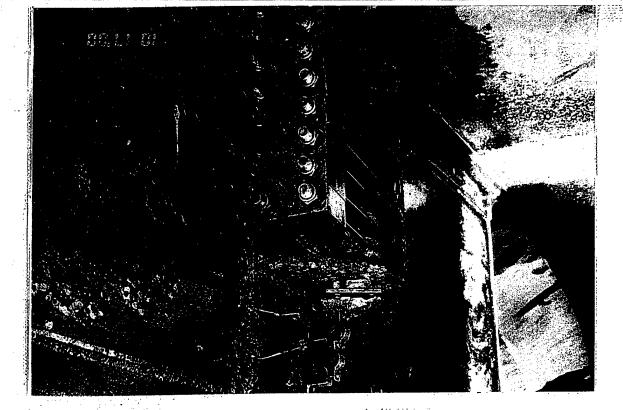
Gate 7
Hoist connection from above. Light to moderate corrosion on lifting lugs and plates. Stainless steel U-bolts and socket blocks in good condition.

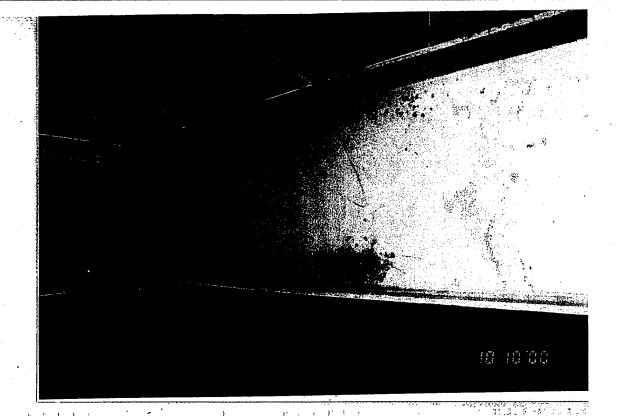
8-1

Little Goose Dam 10/10/00 Gate 8 Left frame Brace C. Light corrosion on brace, typical.

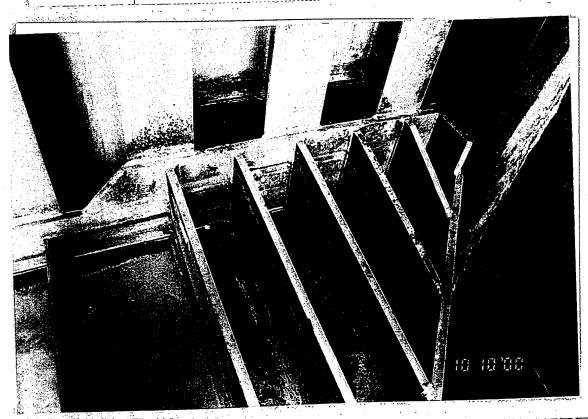
Gate 8
Bottom horizontal girder. Standing water, no drainage between multiple stiffeners, typical. Girder flange to skin plate stiffeners, standing water, no drainage.

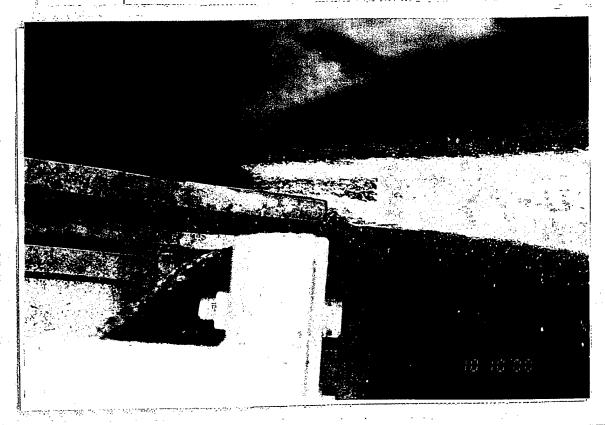
Little Goose Dam Gate 8 Side seal leak, bottom left side of gate.

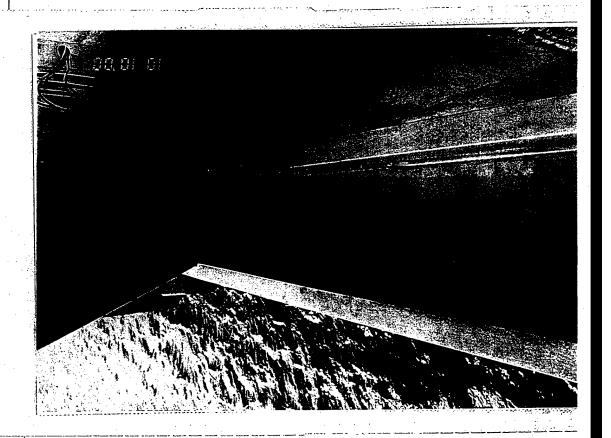
Gate 8
Right frame, middle radial strut, standing water between girder flanges due to drain above (see photo 8-15).

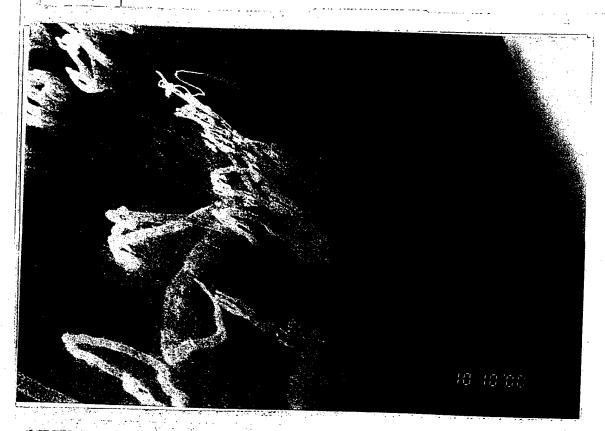
Gate 8
Typical upstream skin plate condition, heavy concentration of pitting.

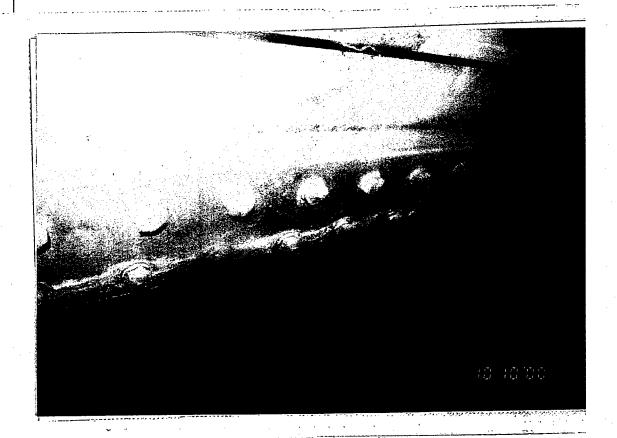
Little Goose Dam Gate 8
Bottom seal keeper plate, typical.
